Accessibility Review
 Riverside Boulevard and West 68th Street Ramp
 New York, NY
 1st Inspection Date: Friday, April 13, 2012
 2nd Inspection Date: Thursday, May 23, 2013

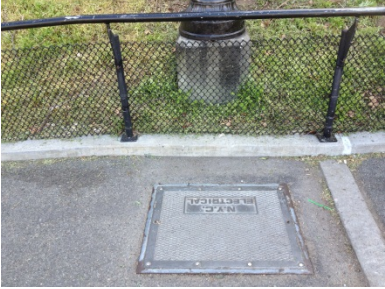
Issue	Applicable Citation
<p>Segment #01, top: 2.33%, 3.10% (+/- 6 feet) Segment #01, bottom: 2.70%, 3.10% (+/- 4 feet) Segment #02, bottom: 3.33%, 3.80% (+/- 4 feet) Segment #03, bottom: 2.60%, 4.20% (+/- 4 feet) Segment #04, bottom: 5.00%, 5.40% (+/- 5 feet) Segment #05, top: 4.50%, 5.50% (+/- 5 feet) Segment #05, bottom: 3.60%, 4.10% (+/- 4 feet) Segment #06, bottom: 2.60%, 4.40% (+/- 4 feet) Segment #07, bottom: 5.80%, 7.50% (+/- 4 feet) Segment #08, bottom: 4.90%, 5.40% (+/- 4 feet) Segment #09, bottom: 2.20%, 1.60% (+/- 4 feet) Segment #10, bottom: 2.20%, 3.30% (+/- 4 feet) Segment #11, bottom: 2.50%, 2.90% (+/- 6 feet)</p>	
<p>In addition, the follow landing were not level due to electrical manhole covers: Segment #01, bottom landing Segment #03, bottom landing Segment #05, top landing Segment #06, bottom landing Segment #08, bottom landing Segment #10, bottom landing Segment #10, bottom landing</p>

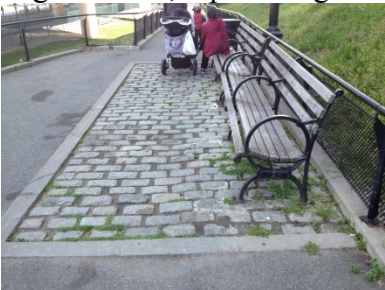
<p>In addition, the follow landings were not level due to cobblestone:</p>

Issue	Applicable Citation
<p>Segment #04, bottom landing Segment #05, top landing</p>

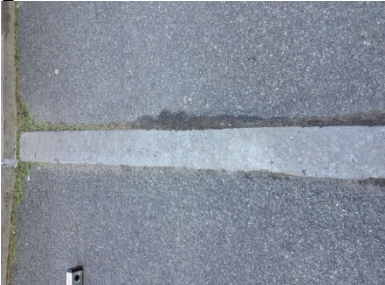
<p>Cross Slope and Surfaces The cross slope of ramp surfaces shall be no greater than 1:50 (2.00%). Much of the ramp had cross slopes that measured in excess of 2.00%.</p>	<p>ADAAG Section 4.8.6</p>
<p>Changes in Level Changes in level up to 1/4 inch may be vertical and without edge treatment. Changes in level between 1/4 inch and 1/2 inch shall be beveled with a slope no greater than 1:2. Concrete strips at the tops and bottoms of ramp segments have changes in level greater than 1/4 inch vertical and 1/2 inch beveled.</p>

<p>ADAAG Section 4.5.2</p>
