A R K A N S A S
Department of Environmental Quality

RE: Riviera Utilities- Diamondhead Inspection (Garland Co)
AFIN: 26-00248 NPDES Permit No.: AR0048615

A R K A N S A S Department of Environmental Quality		WATER DIVISION INSPECTION REPORT					
		AFIN: 26-00248		PERMIT #: AR0048615		DATE: 10/22/2015	
		COUNTY: 26 Garland			PDS #: 087415		MEDIA: WN
		GPS LAT: 34.431167 LONG: -92.949598 LOCATION: General Area					
FACILITY INFORMATION			INSPECTION INFORMATION				
NAME: Riviera Utilities- Diamondhead LOCATION: 440 Catherine Park Rd CITY: Hot Springs, AR 71913			FACILITY TYPE: 2 - Industrial	INSPECTOR ID#: 34689 S - State			
			FACILITY EVALUATION RATING: N	INSPECTION TYPE: Reconnaissance			
			DATE(S): 10/22/2015	ENTRY TIME: 10:00	EXIT TIME: 11:30	PERMIT EFFECTIVE DATE: 10/1/2014 PERMIT EXPIRATION DATE: 9/30/2019	
RESPONSIBLE OFFICIAL							
NAME / TITLE: Jack Plumlee / CEO COMPANY: Lake Catherine Waterworks and Sewer Facilities Board dba Riviera Utilities WWTF MAILING ADDRESS: 440 Catherine Park Rd., Ste C CITY, STATE, ZIP: Hot Springs AR 71913 PHONE & EXT: / FAX: 501-262-1297 / EMAIL: jackplumlee@gmail.com riviera_water@yahoo.com			FAYETTEVILLE SHALE RELATED: N FAYETTEVILLE SHALE

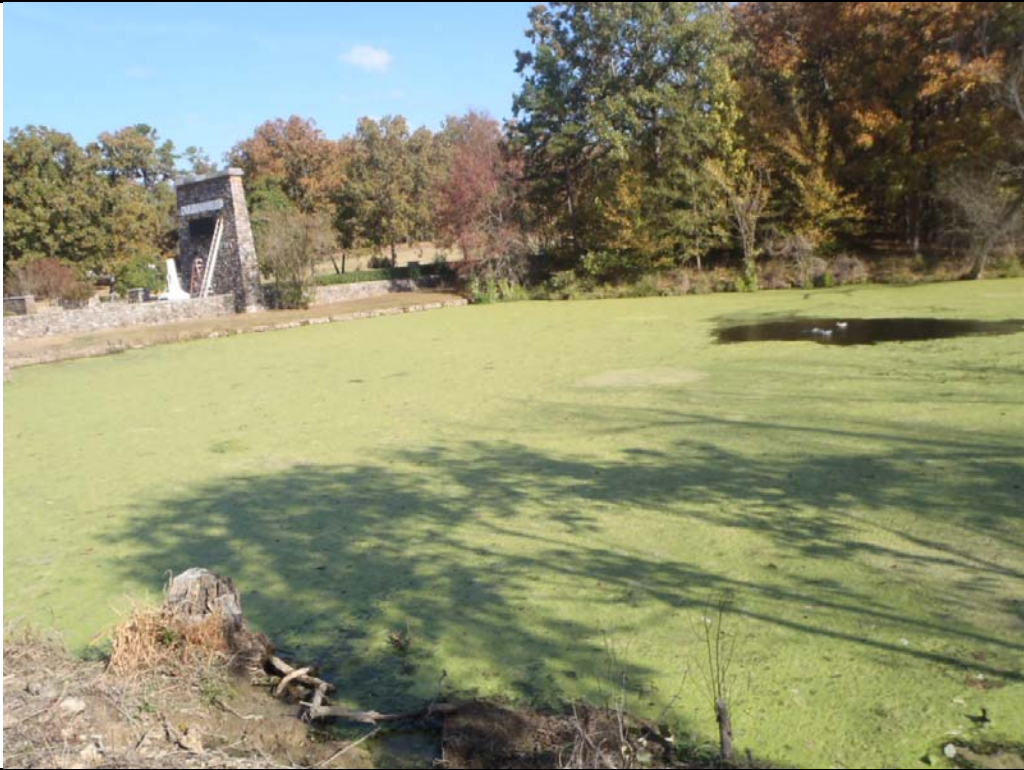
Location:	Riviera Utilities- Diamondhead		
Photographer:	Travis Harmon	Date:	10/22/15
Witness:	Leny Baker	Time:	1040
		Photo #:	1
Description:	View of floating vegetation/algae in receiving water (Pond A in Google Earth image).

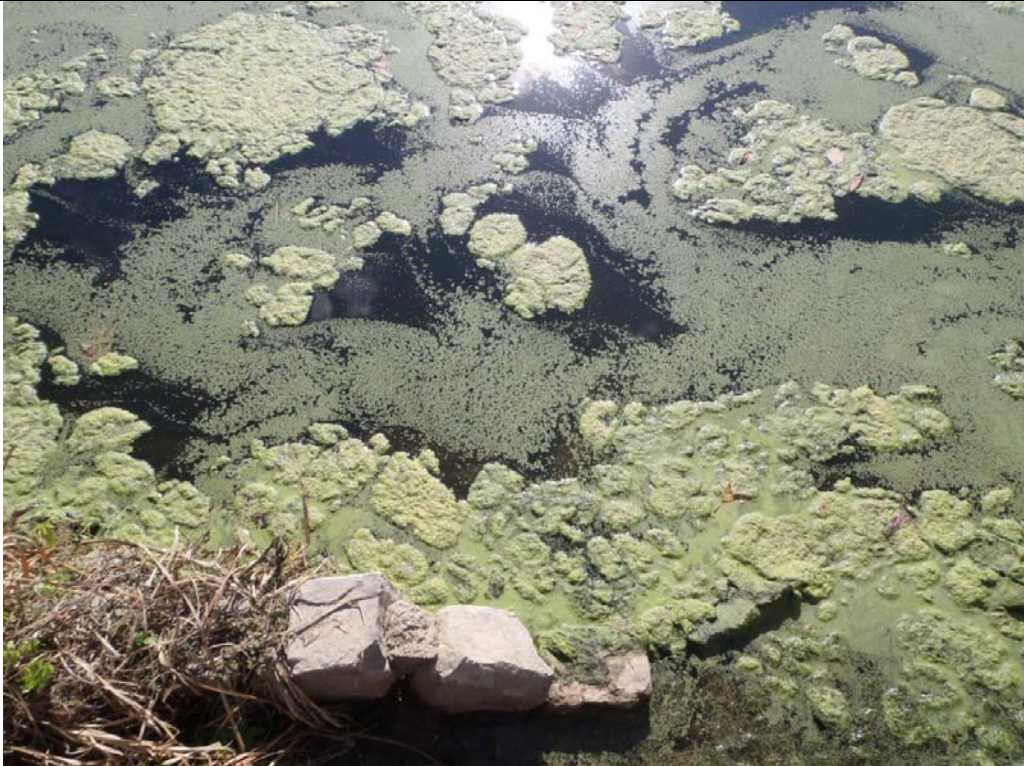
Photographer:	Travis Harmon	Date:	10/22/15
Witness:	Leny Baker	Time:	1044
		Photo #:	2

Description:	Close-up view of floating vegetation/algae in Pond A.
--------------	--

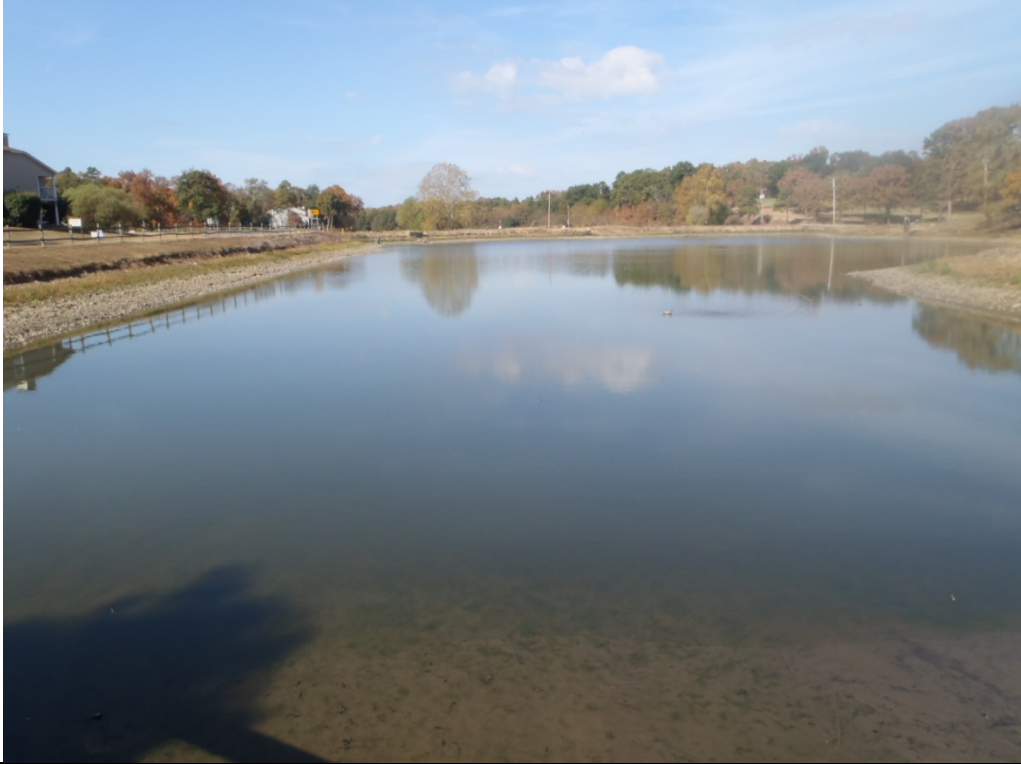
Location:	Riviera Utilities- Diamondhead		
Photographer:	Travis Harmon	Date:	10/22/15
Witness:	Leny Baker	Time:	1052
		Photo #:	3
Description:	Less floating vegetation/algae in Ponds B and C located downstream.

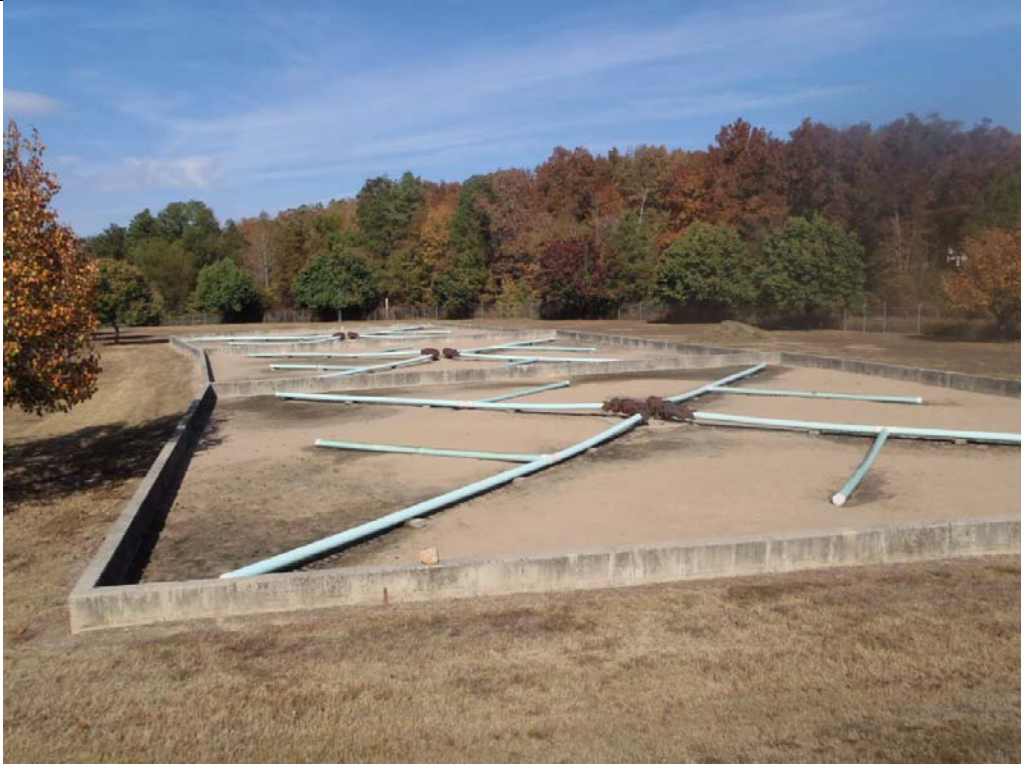
DETAILS: **Assessed existing treatment system maintenance. At the time of inspection, the filter beds appeared maintained and chlorine tablets were in place.**

Photographer:	Travis Harmon	Date:	10/22/15
Witness:	Leny Baker	Time:	1052
		Photo #:	4
Description:	Filter beds were maintained at the time of inspection.

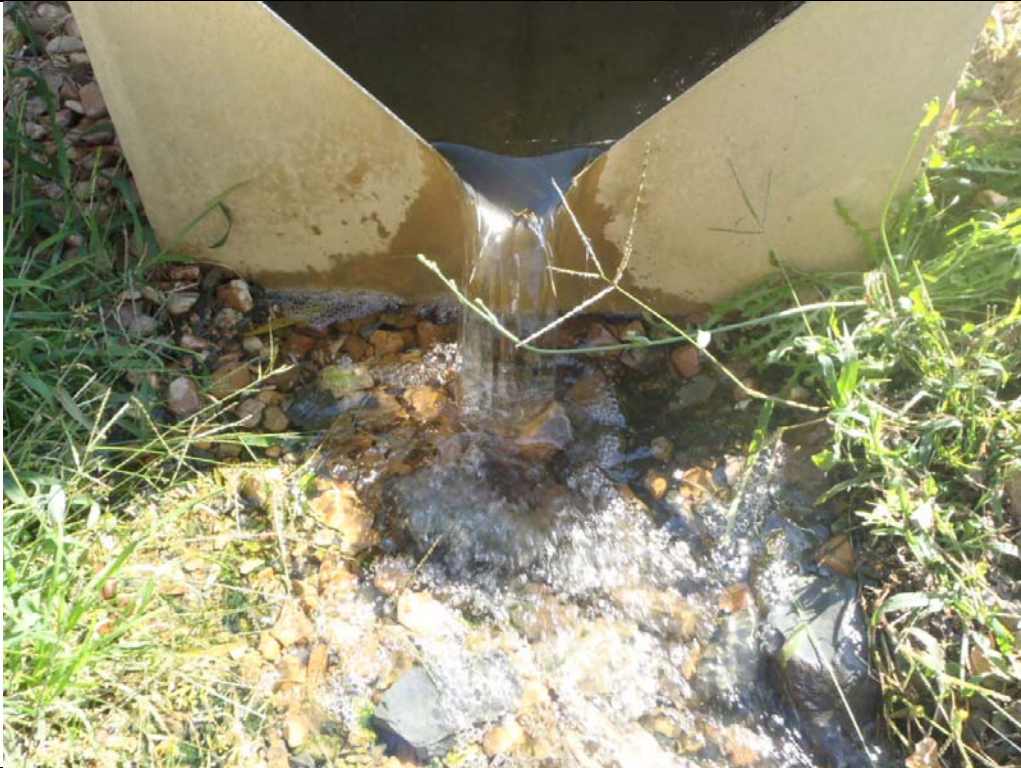
DETAILS: **Viewed as effluent is leaving the weir.**

Location:	Riviera Utilities- Diamondhead		
Photographer:	Travis Harmon	Date:	10/22/15
Witness:	Leny Baker	Time:	1052
		Photo #:	5
Description:	View of treated effluent at the time of inspection. Effluent was clear with no visible indication of non-compliance (Outfall 002 in the Google Earth image).
