## TECHNICAL BULLETIN

# 3-TONNE 'TITAN' BRAND CHAIN BLOCK

## INCIDENT

Lower load hook became detached from the hook block.

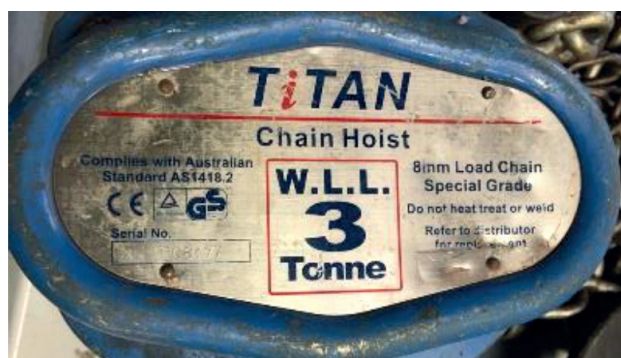
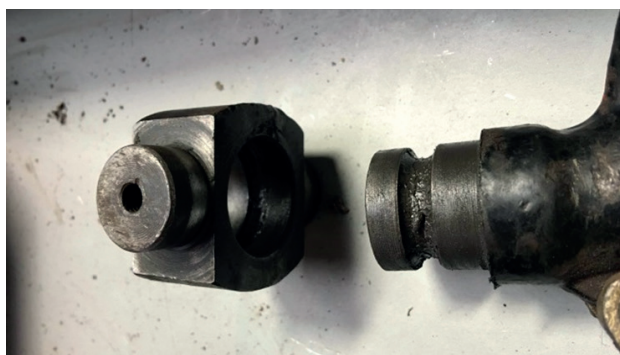
On closer inspection it was noted that the plug, that holds the ball bearings in the crosshead that anchors the hook and allow the hook to swivel, was missing.

This in turn had allowed the bearing balls to escape allowing the hook to become detached.

Close inspection showed no significant wear or fatigue on any component.

All equipment with similar systems for securing the load hook to the block should be closely examined prior to ongoing further use

It is important that inspections are carried out by competent persons.

Lifting equipment inspections are clearly documented, recorded and held on a register.

Inspections are carried out prior to use of any and all items of lifting equipment (ACoP s 5.10).
